Smart motorways

Incident and infrastructure investigation

M1 Junction 39 to 42

Highways England response

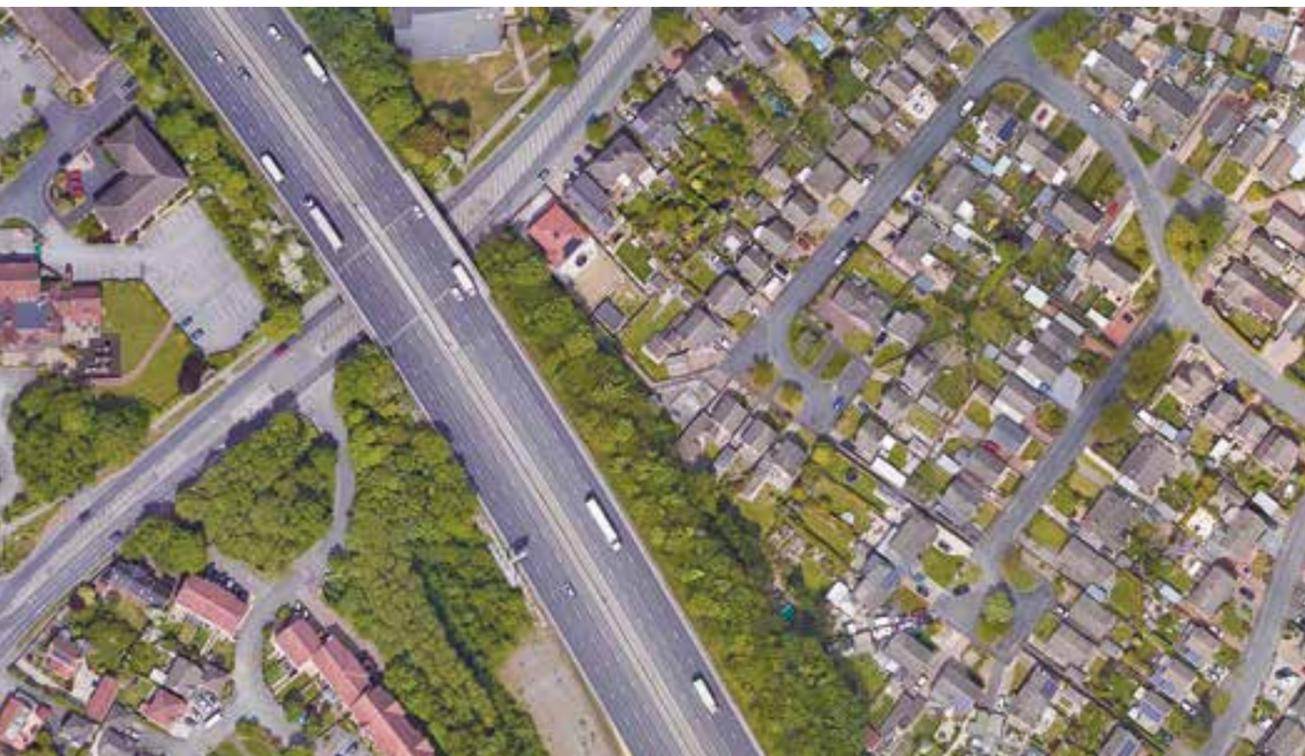
Pedestrian incident reports are most common on the J39 to J40 link, which runs between two suburban areas. The range of potential crossing and access points, and the suburban setting of this link are risk factors and although they appear to serve most pedestrian routes, the provision and fencing details vary.

Figure 1 Public rights of way parallel to and across the motorway between J39 and J40
© Google

Review the access points along the route and install anti-access fencing at specific locations on the J39 to 40 link, to prevent access to the motorway for pedestrians and remove the risk of further incidents.

Consider higher parapets on the overbridges at J40, with Samaritans crisis signs and an emergency telephone for customers in crisis in line with the suicide prevention toolkit. A site assessment has identified these as potential measures to be developed through further feasibility work.

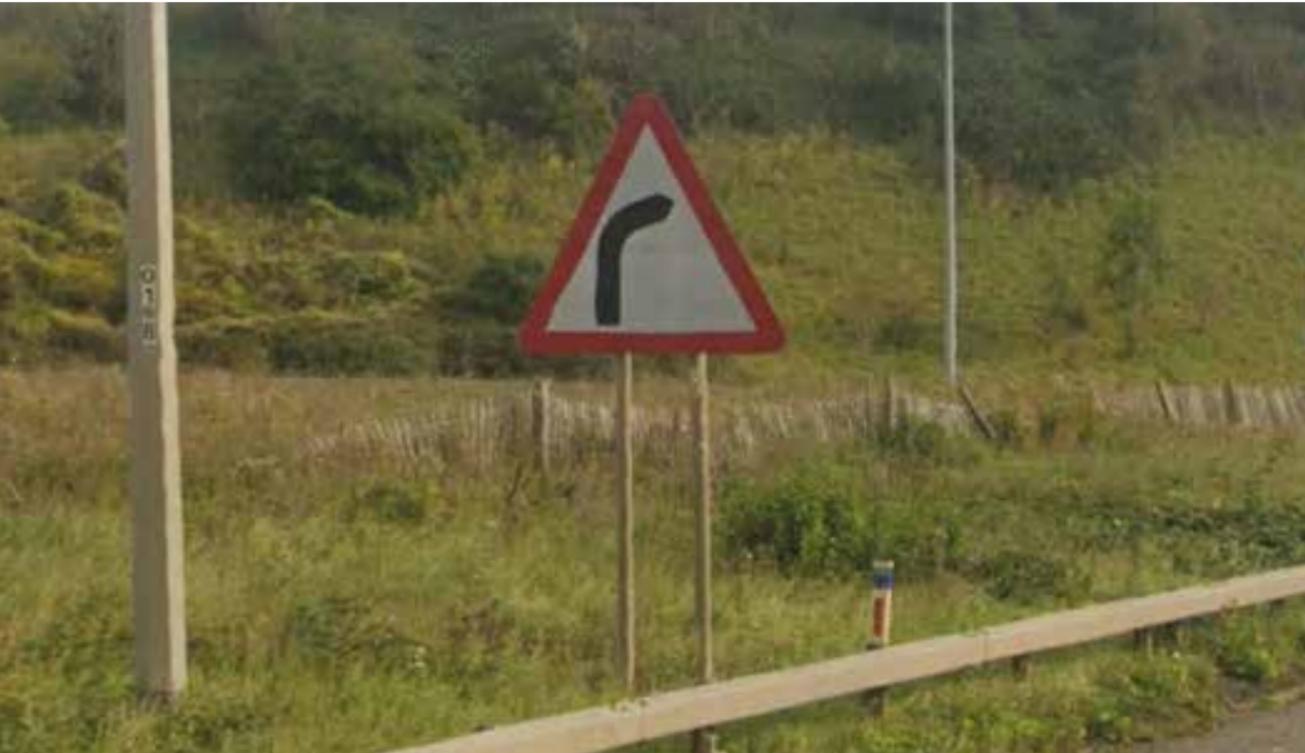
A cluster of collisions has occurred in the area at and immediately north of M1 Junction 39. 23 injury collisions occurred in this locality in the four year after period (2016-2019), of which 30% were serious injury collisions. Unusually for a section close to a motorway junction, there were more loss of control collisions (7) than shunts (6), with lane change collisions also similar in number (5).

It is highly likely that factors such as the curvature of the carriageway, the short northbound entry slip and the Calder Navigation bridge at this point on the M1 all contribute to the increase in collision occurrences and higher severity incidents.

Figure 2 Bend ahead warning sign © Google

We have reviewed the road layout at this point and conclude that it meets all the standards in terms of geometric alignment. The installation of bend warning signs would normally be complemented with the introduction of chevron warning signs, but it is not considered that this is appropriate at this location.

Potential Intervention 1 will not be progressed as the introduction of signs would have little impact at this location. Bend ahead warning signs would be largely masked to higher speed traffic by slower/larger vehicles in lane 1.

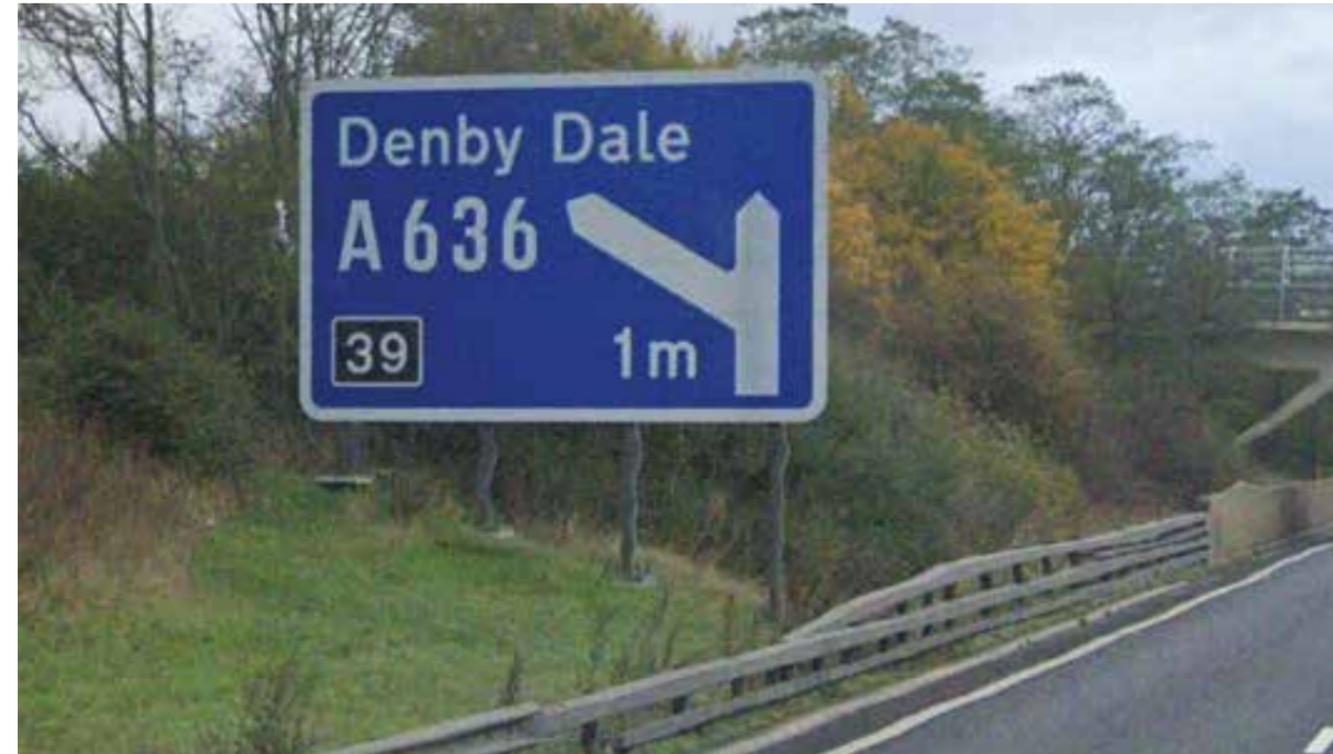
As a lane-drop junction, this location results in a significant number of lane change movements southbound. The primary 1 mile direction sign is verge mounted map-style and does not indicate a lane-drop road layout. The sign is situated immediately after other signing and an emergency area, which may draw road user's attention away.

Figure 3 Verge mounted primary 1 mile direction sign on the southbound approach to J39 © Google

There have been four injury collisions recorded in the vicinity of the lane-drop in the four year period (2016-2019), three recorded as serious and one slight collision.

The lack of signing accurately reflecting the road layout.

- It is proposed the existing verge mounted Advanced Direction Sign is replaced with a different authorised sign which better reflects the lane drop layout at this junction.

It is recommended potential intervention 1 is progressed and new signing installed.

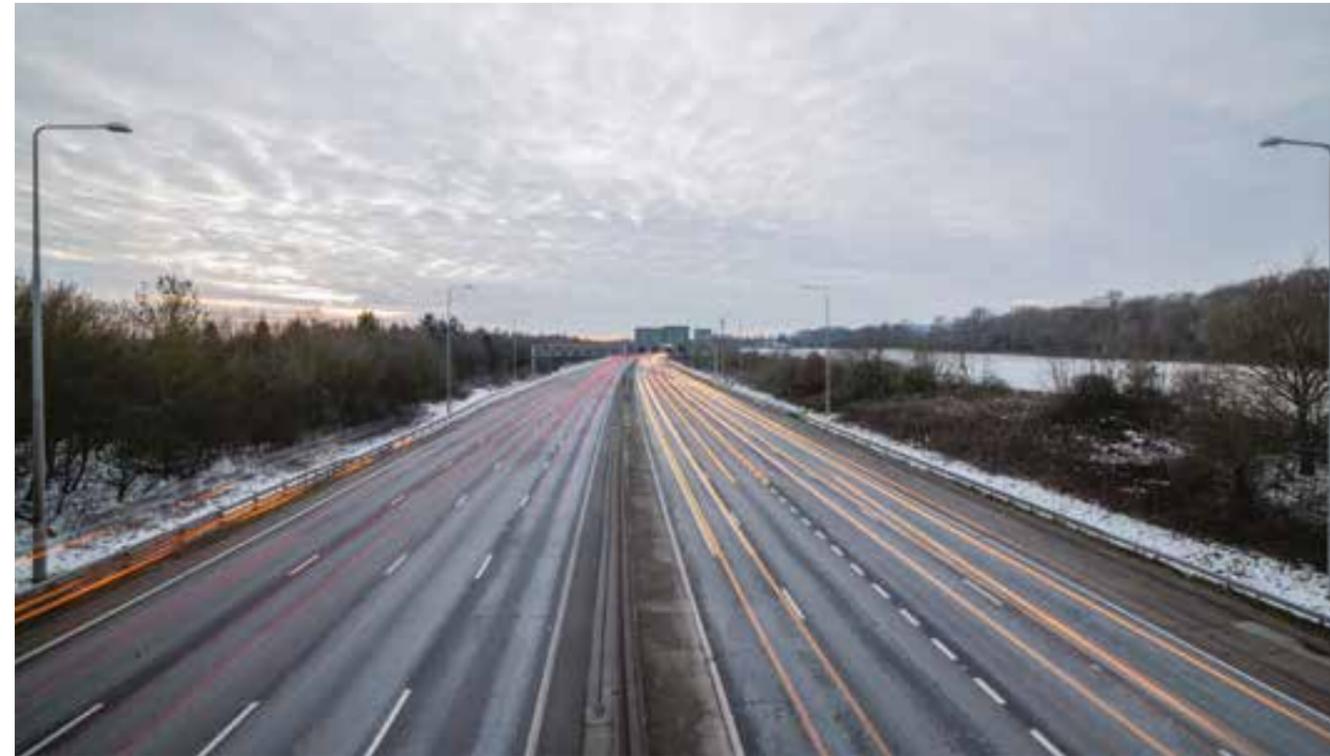
An analysis of collision data indicates an increase in the number of collisions occurring in darkness for the scheme compared to the period before the smart motorway was implemented (from 6.7 per year to 9 per year). 37 injury collisions during darkness have been identified after scheme opening; one fatal, nine serious and 29 slight casualties.

Seventeen injury collisions have been recorded in the link between J39 and J40, and ten between J40 and J41. Both links are approximately 2.5 miles (4 km) long and unlit. Ten collisions occurred in the 1.2 mile (2 km) long lit link between J41 and J42.

Figure 4 Example of motorway lighting

We have reviewed the location and consider that the cost of installing a street lighting system over a distance of 2.5 miles (4 km) could be disproportionate and its value needs to be considered carefully. Our standards for deciding whether to install lighting consider multiple factors, including expected safety benefits, environmental considerations (such as the additional emissions that are required) and the costs.

A further, more detailed study will be carried out to establish the benefits of installing a street lighting system and improved markings and road studs.

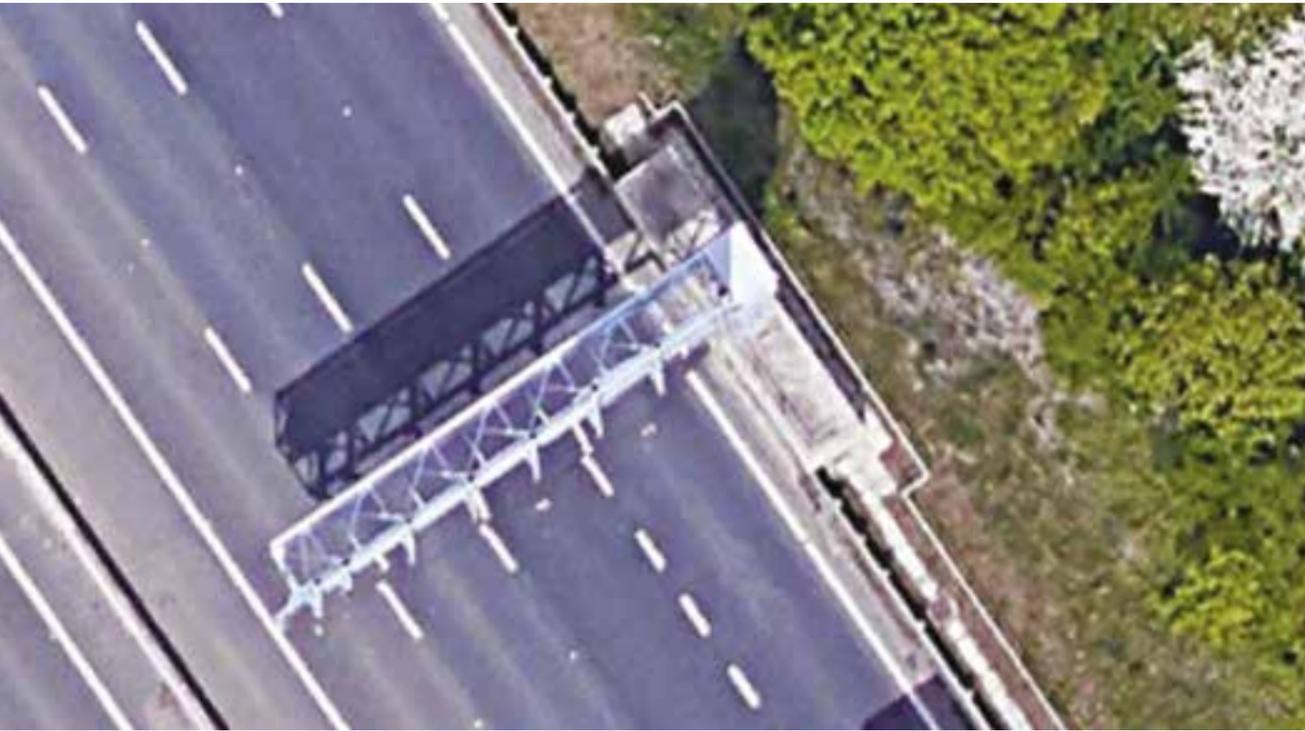
A cluster of collisions is evident on the southbound carriageway and exit slip road, at and immediately north of M1 J39. Nine injury collisions were recorded in this locality in the four year after period (2016-2019), of which four (45%) were serious injury collisions.

It is possible that the combination of the horizontal curve and unclear signing related to the lane-gain / drop arrangement, is causing some confusion for motorists on the approach to the junction.

Figure 5 Change in lane markings between lane 1 and 2 at the 1/2 mile marker to the junction © Google

- A hazard lane marking is in place on the southbound carriageway from the 1/2 mile marker to the junction. The extension of this marking northwards to the 1 mile marker would give better guidance for road users. Implementation is subject to the necessary approval.

We will progress potential intervention 1, subject to discussions with signing specialists and any necessary approvals.

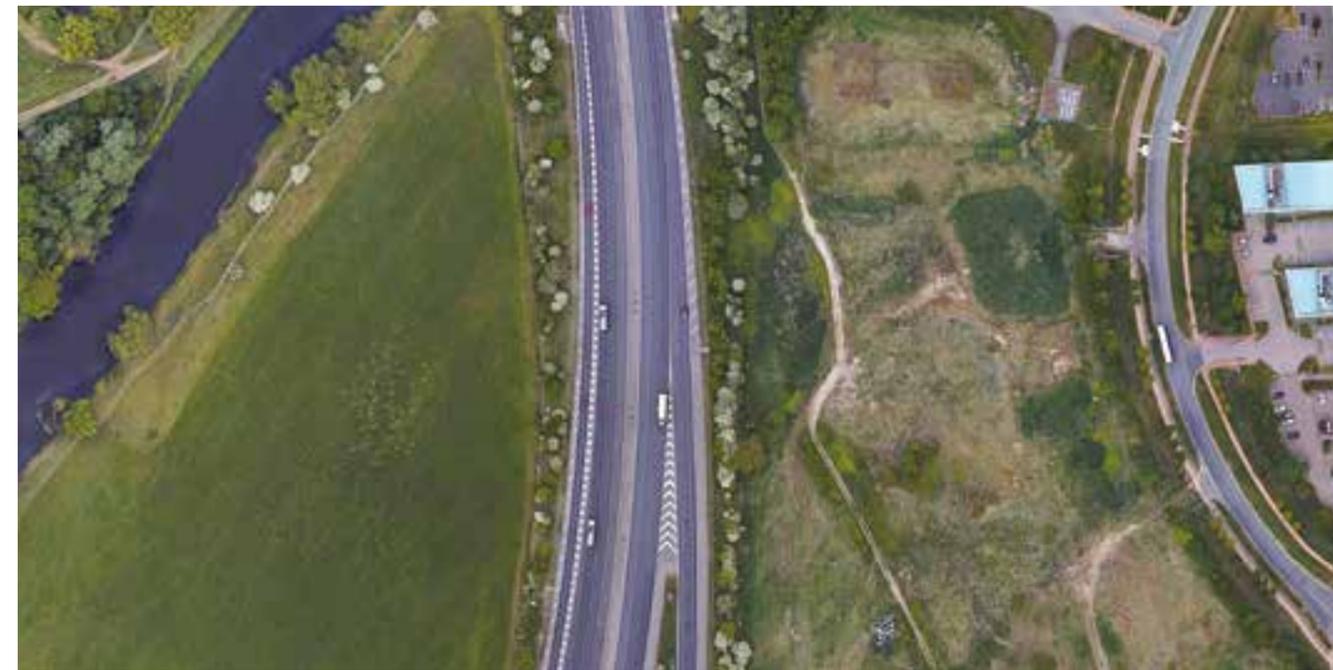
The combination of the horizontal curve and the signing related to the lane gain / drop arrangement, appears to be creating confusion for motorists on the approach to the junction which is resulting in late lane changes.

Figure 6 M1 J39 southbound exit slip road (shown on right portion of image) © Google

The arrangement on the southbound approach to Junction 39 in terms of its layout, road markings and signing, while within standards, combines a number of issues which appear to cause road users confusion leading to late lane changes

Carry out a study to investigate the possibility of installing an alternative exit slip road layout

Intervention 1, a study into a potential new exit slip road layout for J39, will be progressed to identify suitable options.

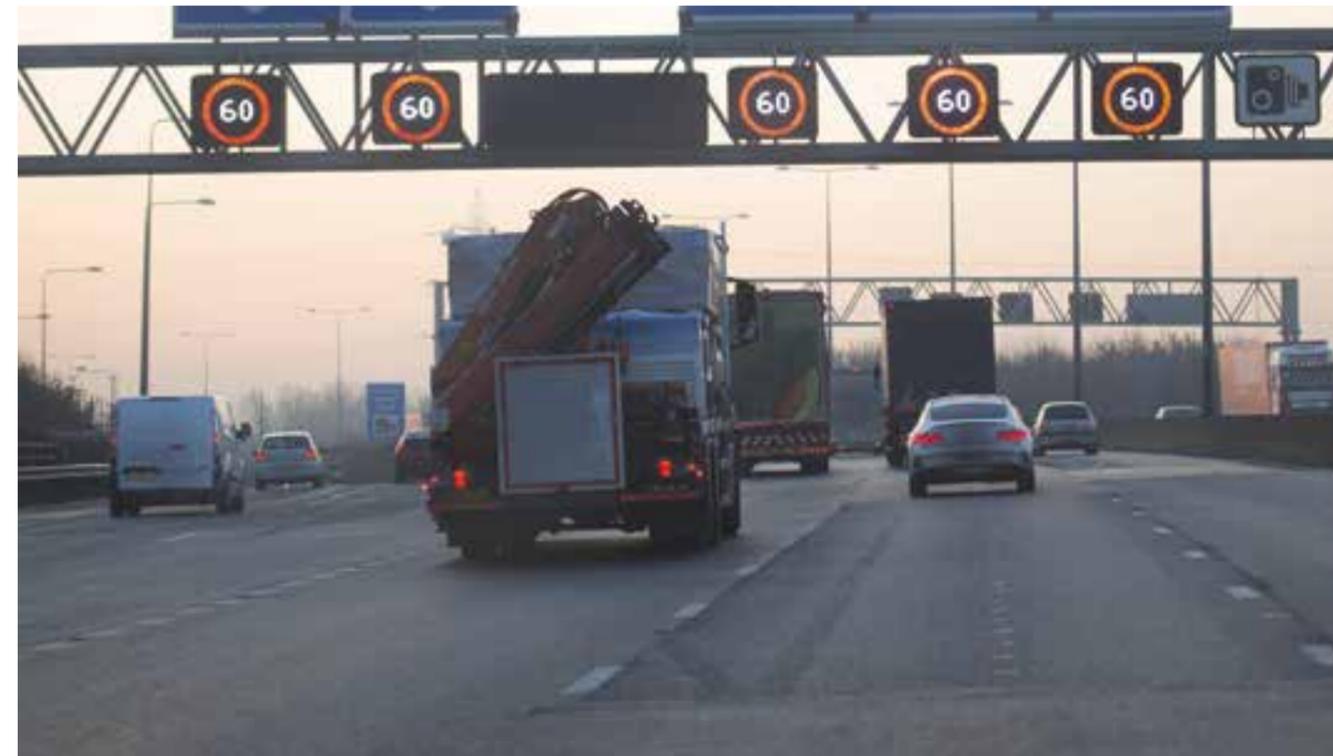
The accident data shows that generally the collision types are spread out across the northbound and southbound collision clusters and there is not much of a pattern. In the northbound direction there are two shunt type collisions just before the merge with lane 2, which suggests that some drivers may be nervous about entering the carriageway. Just after the merge there are three loss of control type collisions, which could be related to speeding. In the southbound direction there are three shunt type collisions near the merge and on the slip road, but still quite far apart from each other and the loss of control type collisions are spread out.

Figure 7 Variable speed limits in operation

We have reviewed the location and believe that this method of reducing any congestion is not appropriate on the M1 junction 39 to junction 42 smart motorway scheme. This is because the extra capacity generated by installing additional lanes has mostly eliminated peak time congestion.

The display of variable speed limits earlier, prior to peak periods will not be progressed.

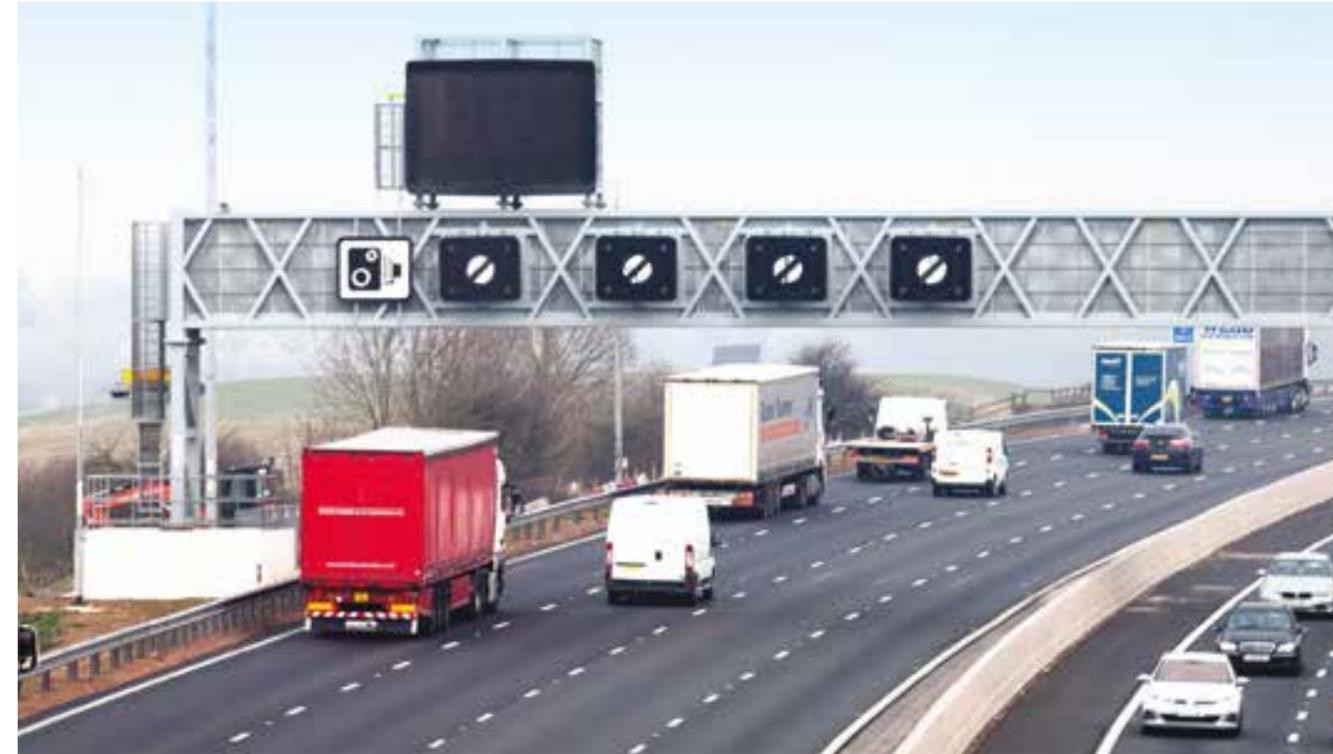
- Constraints imposed by Calder Navigation Bridge, particularly the parapets. A departure has been identified in the Design Strategy Record for the scheme identifying constraints relating to the J39 northbound stopping sight distance (SSD) – Lane 1 SSD reduced by a maximum of 3 steps (to 160 metres) to low and high objects due to the bridge. Although this does impact the stopping sight distance just north of J39, this is likely not the primary cause of the collision cluster due to the location of the collisions. Most of the collisions are further south than the Calder Navigation bridge. However, the location of the bridge does have an impact on some of the other factors including the junction layouts.

- The horizontal left-hand curve just north of J39. This also impacts the stopping sight distance in this area. This could be a contributory factor to the collision cluster, but is unlikely the primary cause as the collisions are south of the bend.

- The junction layout at J39. On the northbound carriageway there is a lane gain with a second lane that merges with lane 2, which is short. Evidence suggests that at peak times the traffic is heavy, and vehicles often drive too quickly and have to brake suddenly when they merge with lane 2. Traffic count data reflects this, with 1800 vehicles per hour entering the carriageway here at the morning peak. On the southbound carriageway there is a pattern of weaving and vehicles swooping in to leave the carriageway at the last minute.

Figure 8 National speed limit displayed on signals

We have investigated the location and believe there is no evidence to suggest that displaying the national speed limit outside of peak hours would provide greater control or improve driver behaviour at the junction. It would also be unusual for drivers to see these signal settings and it could affect driver speed compliance on other parts of the road network.

The display of national speed limit outside of peak periods will not be progressed

We will progress a detailed feasibility study to consider improvements to enforcement and potential alterations to the junction layout including merges and diverges. This will be considered as part of the alternative diverge study above.

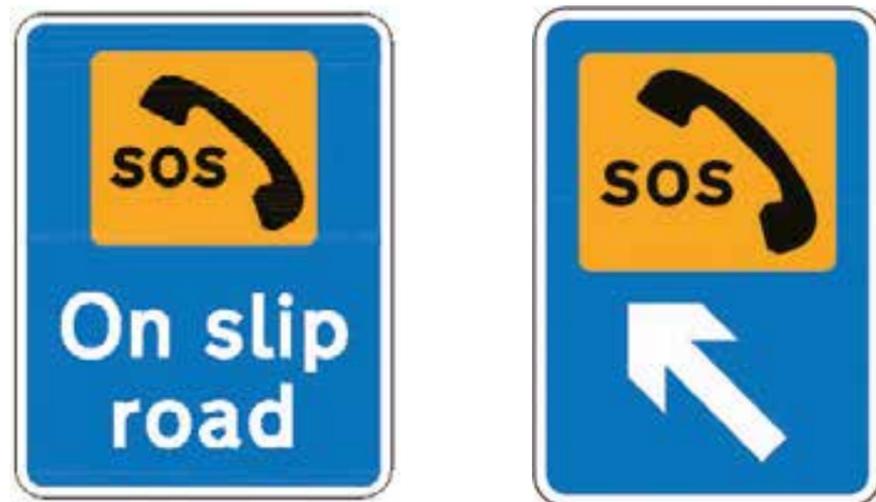
The suggested intervention to add specific signing for exit slip road slip hard shoulders as places of relative safety is already being taken forward.

Figure 9 Approach signs indicating the presence of an emergency roadside telephone adjacent to hard shoulder on an exit slip road

This is as part of the stocktake action to increase the amount of approach signage to places to stop in an emergency, which includes hard shoulders on slip roads, where present.
