# Smart motorways

Incident and infrastructure investigation

M1 Junction 10 to 13

Highways England response

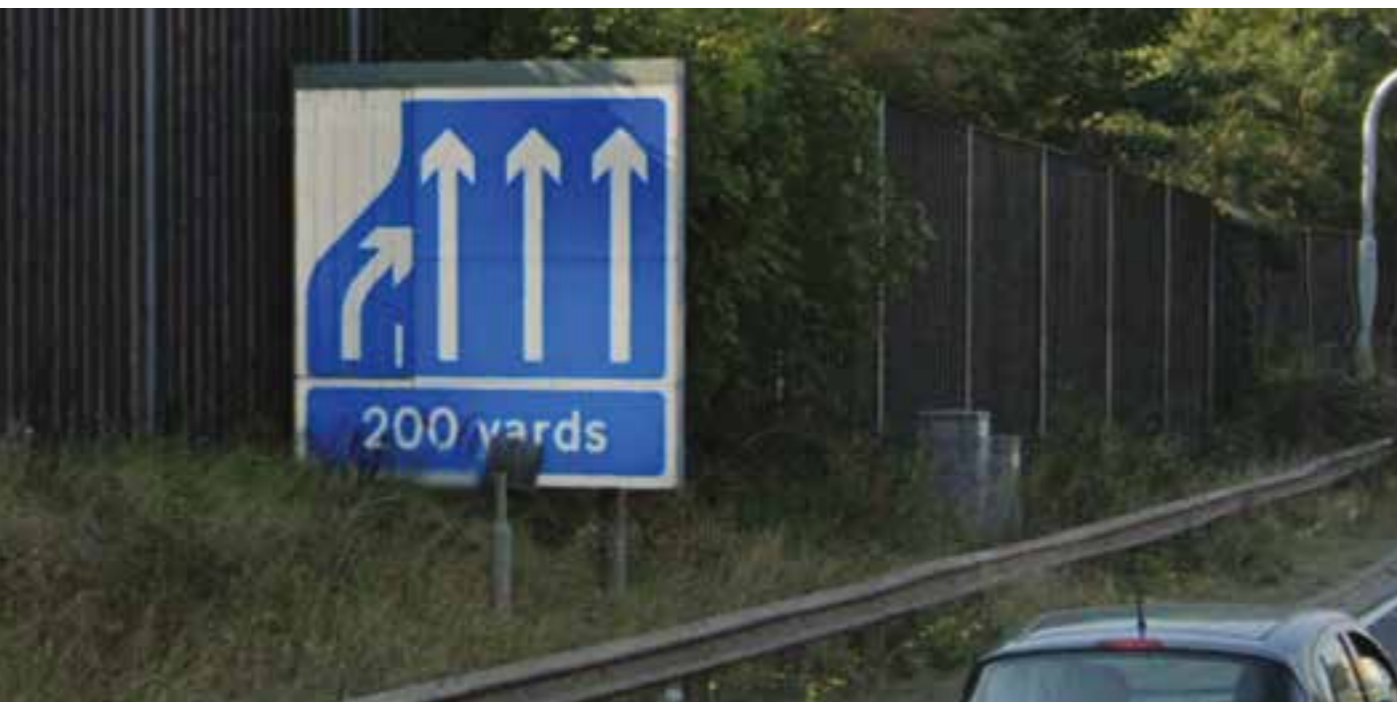
Increasing the number of verge signs for the transition from through junction running to DHS downstream of the junction entry slip roads. This gives additional warning and instruction for all drivers, but particularly those in the hard shoulder and adjacent lane. The signing is currently limited to one sign, with the exception of the northbound approach to junction 10 where two signs are provided. The proposal is to provide a more consistent approach across the scheme.

Figure 1 Verge sign showing the status of the downstream hard shoulder © Google

There are fixed FTMS in the verge across the scheme which show the status of the hard shoulder after each entry slip road. With the VMS also showing the status of the hard shoulder, there would be little benefit from putting a third sign in after every merge. The installation of new signs needs to be considered holistically with other communication elements such as the number of Hard Shoulder Cameras (HSM). Initial investigation also highlighted potential issues with available verge space.

We do not propose to progress these interventions because the mitigations implemented in 2015 appear to show improvements. The verge constraints of installing new signs would mean solutions would not be possible in the short term. Also, as the area is programmed to be converted to ALR in 2022, any interventions would provide limited, if any timely benefit, prior to being removed in readiness for construction. The conversion to ALR will eliminate the mis-use of the hard shoulder.

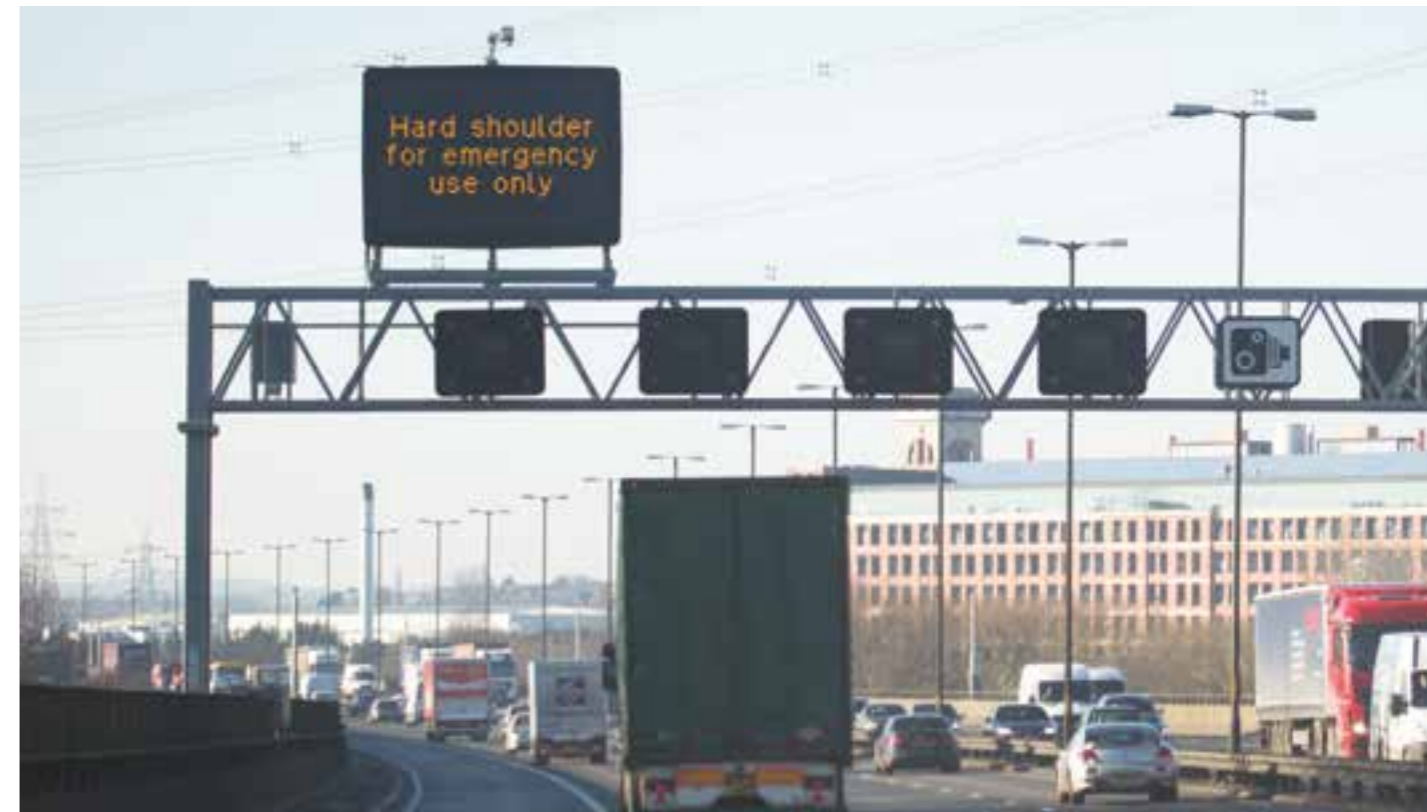
Figure 2 Example of a VMS confirming the status of the hard shoulder

Consistent and repeated messages confirming the status of the hard shoulder have already been implemented on every other variable message sign (VMS) and introduced nationally in 2015. Evidence suggests that this mitigation is working, and it is unlikely that more messages would make a positive difference. There is likely to be very little benefit and some disadvantages from putting a third message in after every entry slip road on top of the fixed text message signs (FTMS) in the verges and VMS. It is felt it would undermine any incident management signs.

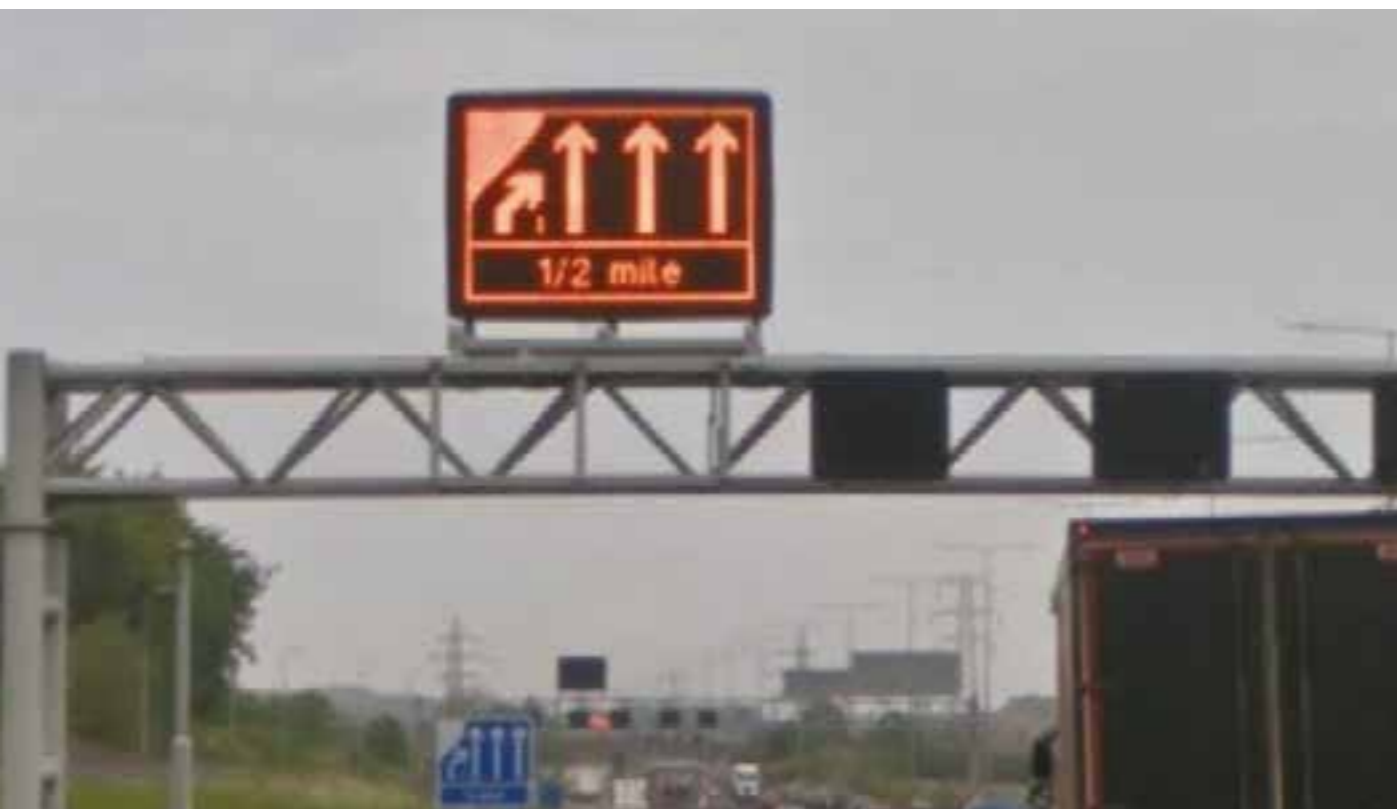
Utilising the existing VMS within the junction on the overhead gantry (location 54/4 southbound) to display an image showing the downstream hard shoulder status. This is already in place at J10 of the M1 (shown below).

Figure 3 VMS showing the status of the downstream hard shoulder © Google

This solution would not inform traffic merging at J11, but would inform mainline traffic of the downstream hard shoulder status, helping to mitigate the issue.

We are carrying out further exploratory work to assess the technical requirements. Initial feasibility suggests this would be possible and at minimal cost with no requirement for road closures or traffic management.

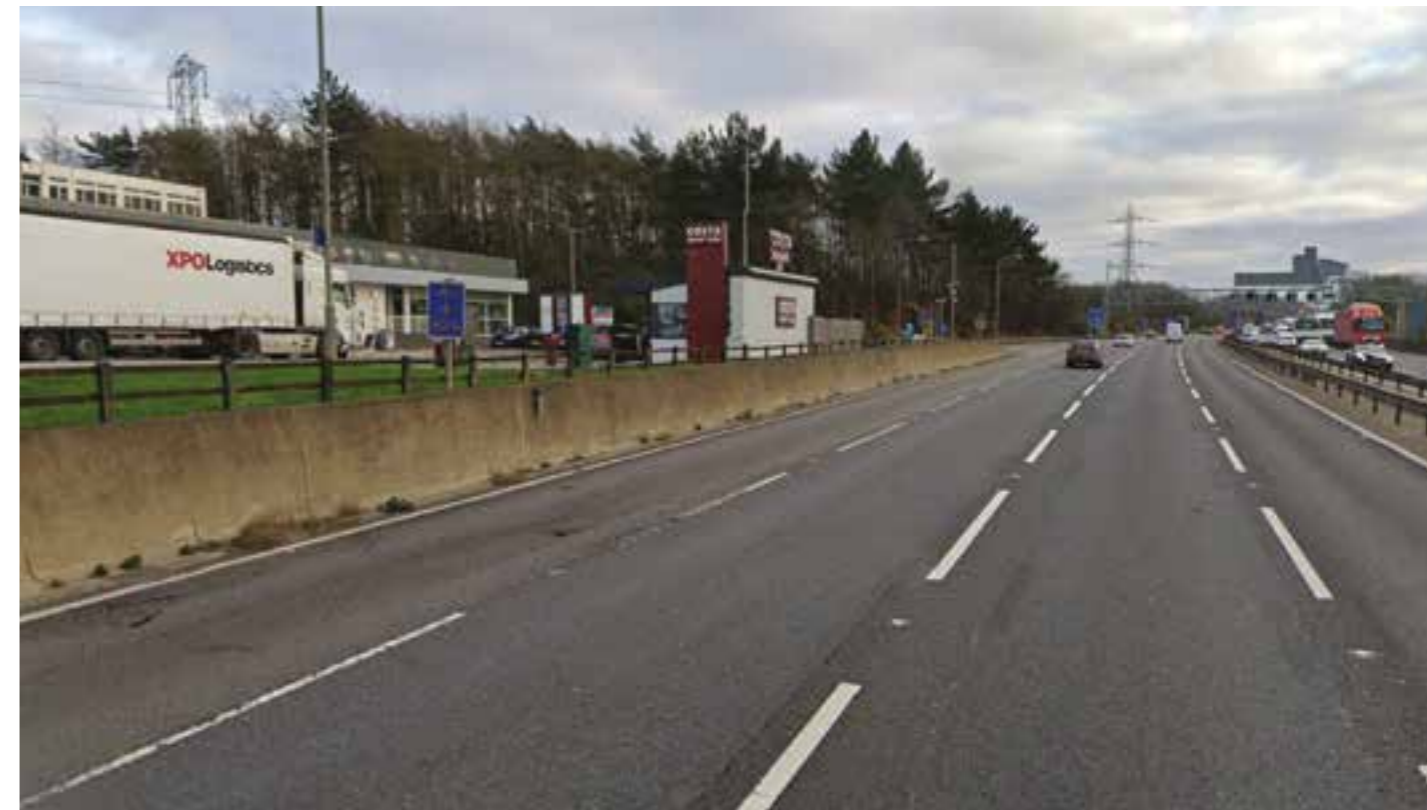
There is currently a concrete barrier in place. This could, in part, be removed and replaced with a lower height steel barrier to improve visibility to the M1 mainline from the entry slip road entry from the motorway service area. There were five injury collisions recorded at this location, and the existing nearside concrete barrier appears to partially obscure the views of drivers.

Figure 4 Toddington Motorway Service Area southbound merge showing concrete barrier  
© Google

Our initial assessment highlights some challenges that require a more in-depth assessment before we can fully determine viability. This includes the vertical concrete barrier, which is in place to protect a footbridge structure linking the northbound and southbound service areas. Any alteration to the concrete barrier must not impede the level of protection offered to this structure. There is also a drive through refreshment facility in very close vicinity to the existing barrier which would need to be taken into consideration. The age and construction of the existing footbridge will inevitably require asbestos surveys to determine likely mitigation and control measures if disturbed. It is on the Asbestos register and scheduled for replacement between 2025 and 2030. We will need to carry out further assessment and it is a possibility that improvements to signs could alleviate the requirement for this intervention.

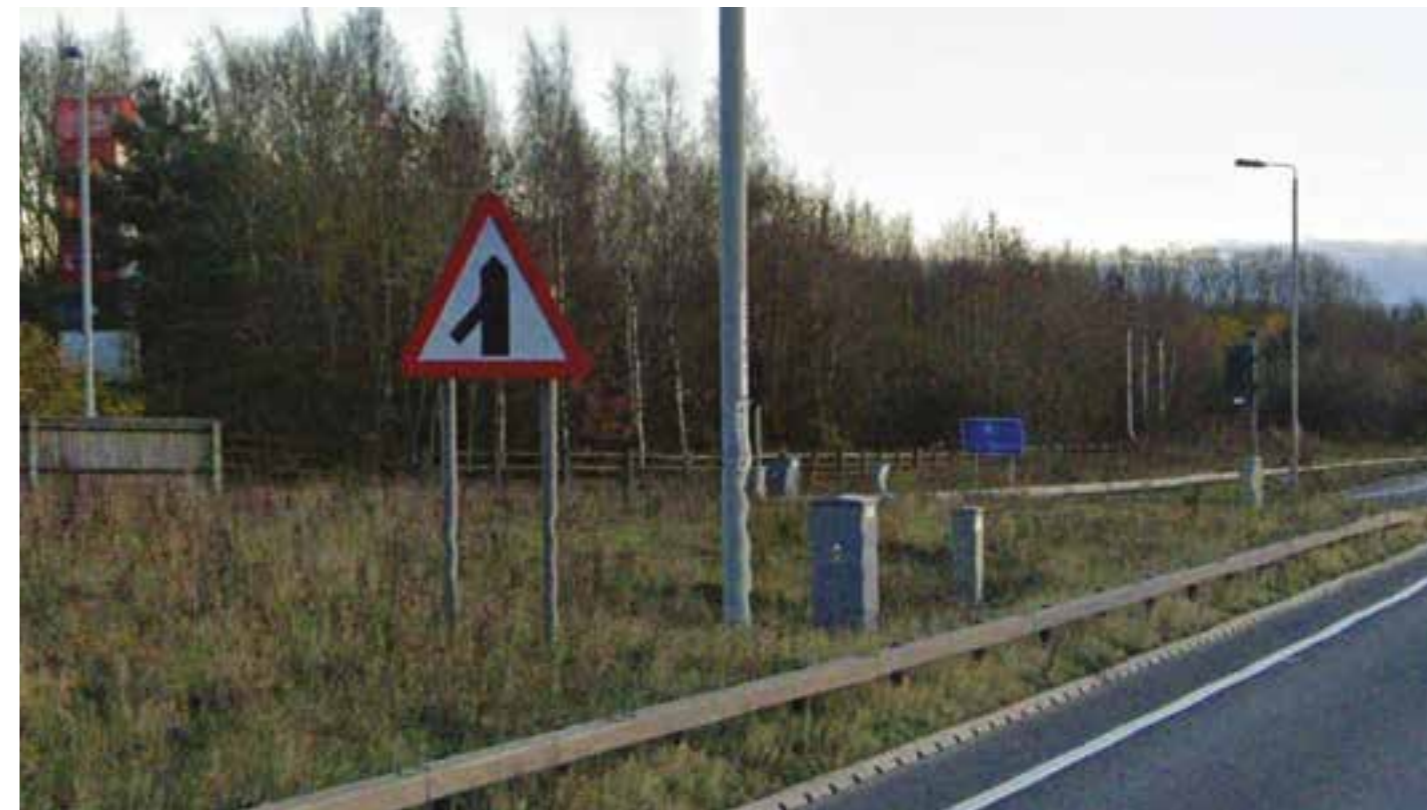
Figure 5 Sign warning of traffic merging from left © Google

Our initial assessment demonstrates that there are potential locations available for increased signs, and there are locations available which would provide minimal disruption. It was found the lines at the start of the DHS have degraded, so we could improve these to make them clearer. We are therefore making sure this is implemented at the earliest opportunity.

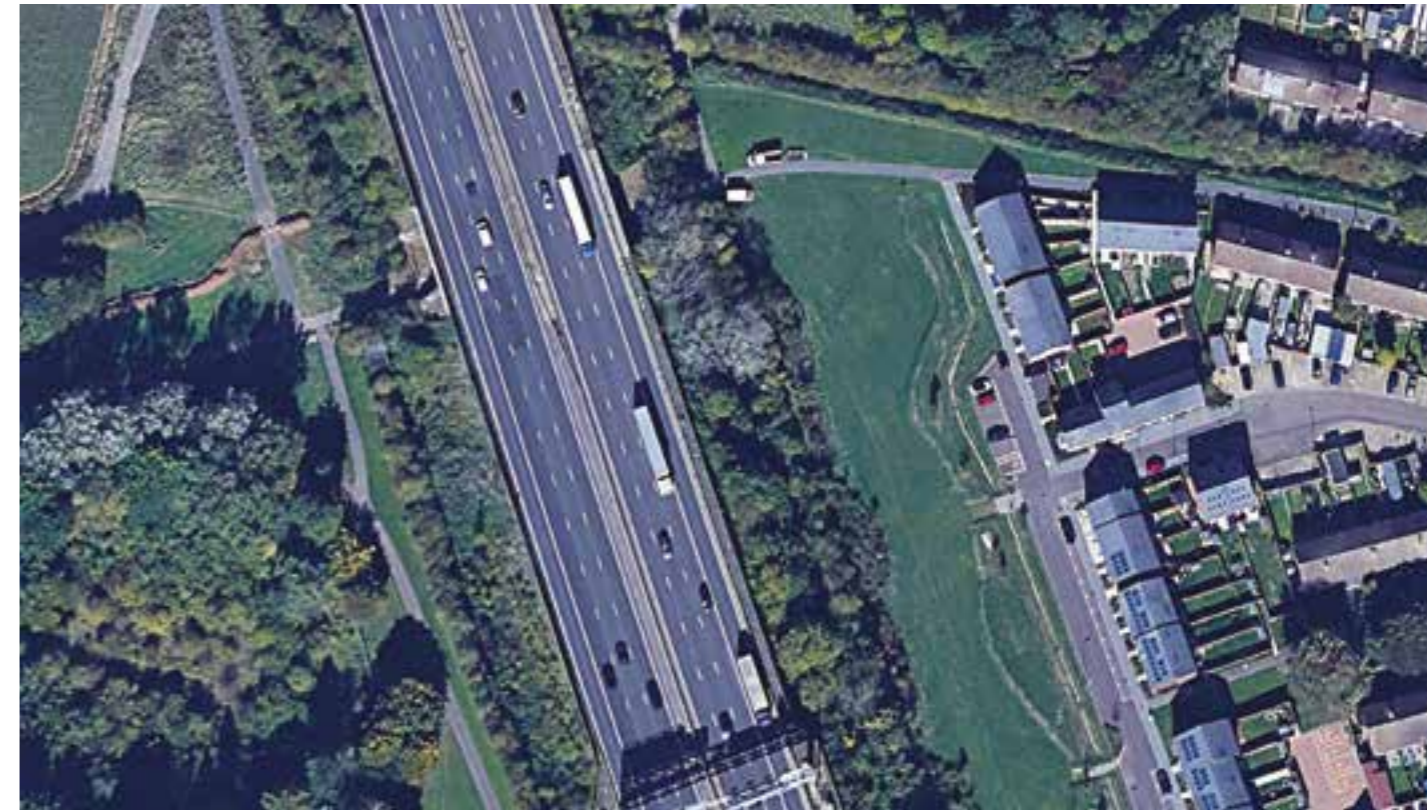
- A slight injury collision, also in 2017, involving an intoxicated pedestrian in the carriageway approximately one kilometre north of junction 11a. The collision occurred along a section where a public footpath runs parallel to the M1 on its east side for approximately a kilometre. There are public rights of way linking Upper Sundon with Fancott and Chalton across the motorway at this point via two accommodation bridges.

Figure 6 Public rights of way parallel to and across the motorway north of M1 J11  
© Google

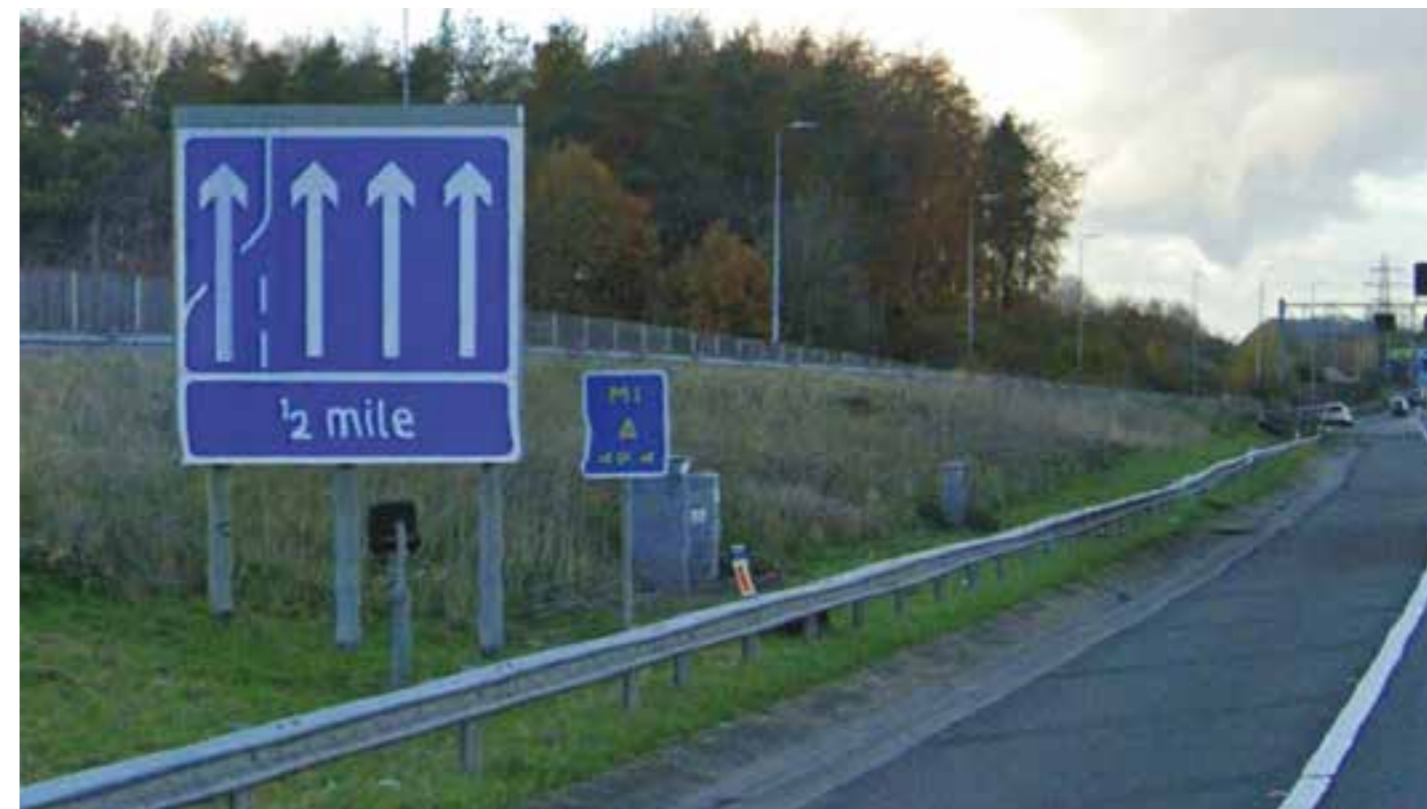
Assess the maintenance regime associated with the rotating fixed text message signs (FTMS) and ensure repair response times align with the signs' operational importance. If necessary, investigate replacing or supplementing with aspects on existing digital signs.

Figure 7 Verge FTMS showing the status of the downstream hard shoulder © Google

The initial issues regarding the rotating fixed text message signs and maintenance has improved and reports of failure are less frequent. New motors are potentially available that could reduce the need for future maintenance, however it is felt that this could prove an unproductive solution given the lead in times for attaining the parts required, particularly as they will be removed once the ALR upgrade goes into construction in 2022. Similarly, we do not think installing new electronic signs for this purpose is a suitable solution as they would be removed as part of the ALR upgrade. The upgrade to ALR will eliminate this issue.

The maintenance issues have been addressed and are less frequent, however we will continue to look at improvements. We do not feel it is appropriate to replace the signs at this stage prior to the ALR upgrade, as the issue will be eliminated by the upgrade to ALR and the signs removed when the scheme goes into construction.

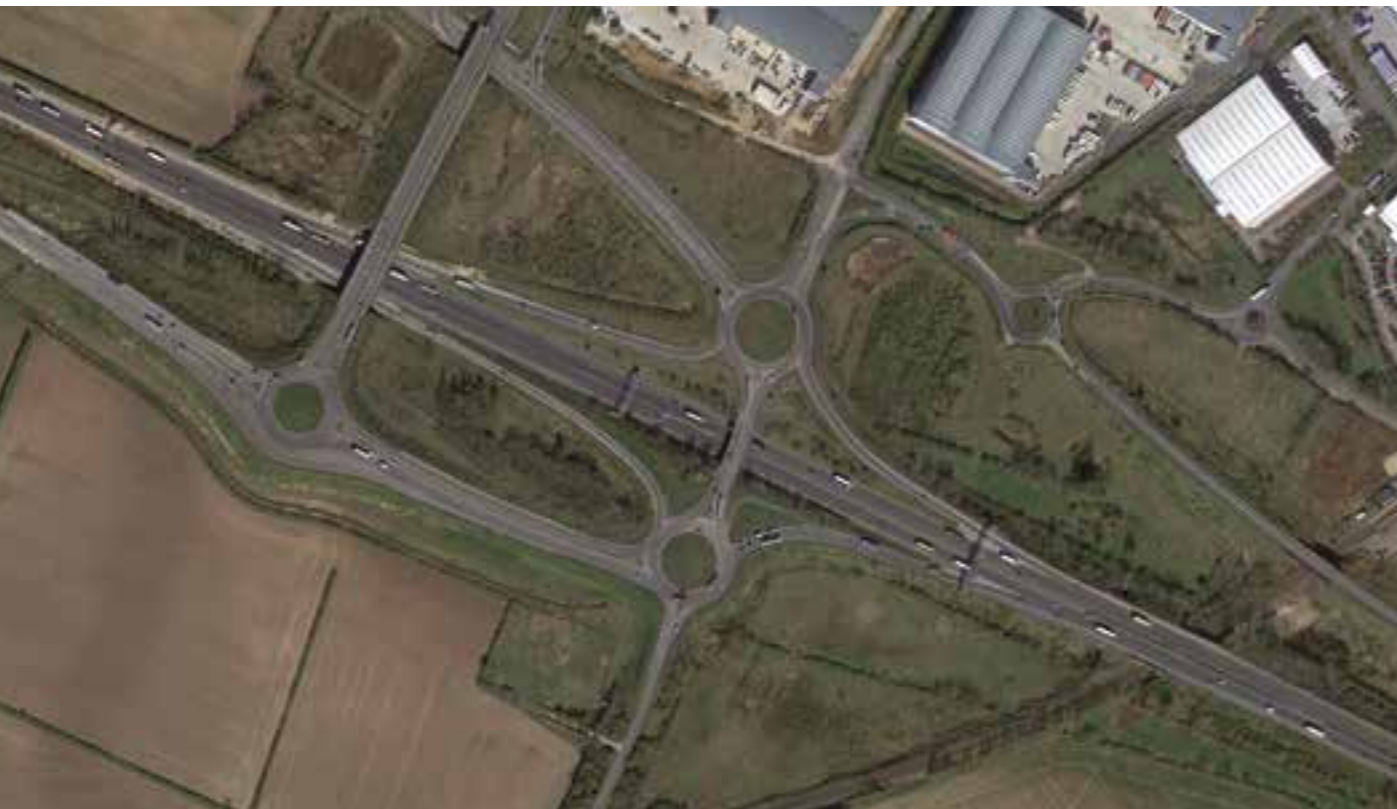
The current conversion of the M1 J13 to 16 from a conventional motorway to all lane running could introduce another transition between operating regimes and cause confusion for drivers. The M1 J13 to 16 is due to open for traffic in 2021 but the M1 J10 to 13 upgrade is not due to start on site until the latter end of 2022, so there will be an interim period before all sections of the M1 covering junction 13 are converted to ALR.

Figure 8 M1 J13 where there is a transition between different schemes © Google

It is recommended that a review of the risks associated with the interim transition between the ALR scheme between junction 13 to 16 of the M1 and the DHS at junction 13 is carried out.
